[Docket No. 2000-SW-65-AD; Amendment 39-12106; AD 2000-25-54]

Airworthiness Directives; Agusta S.p.A. Model A109E Helicopters

2000-25-54 AGUSTA S.p.A.: Amendment 39-12106. Docket No. 2000-SW-65-AD.

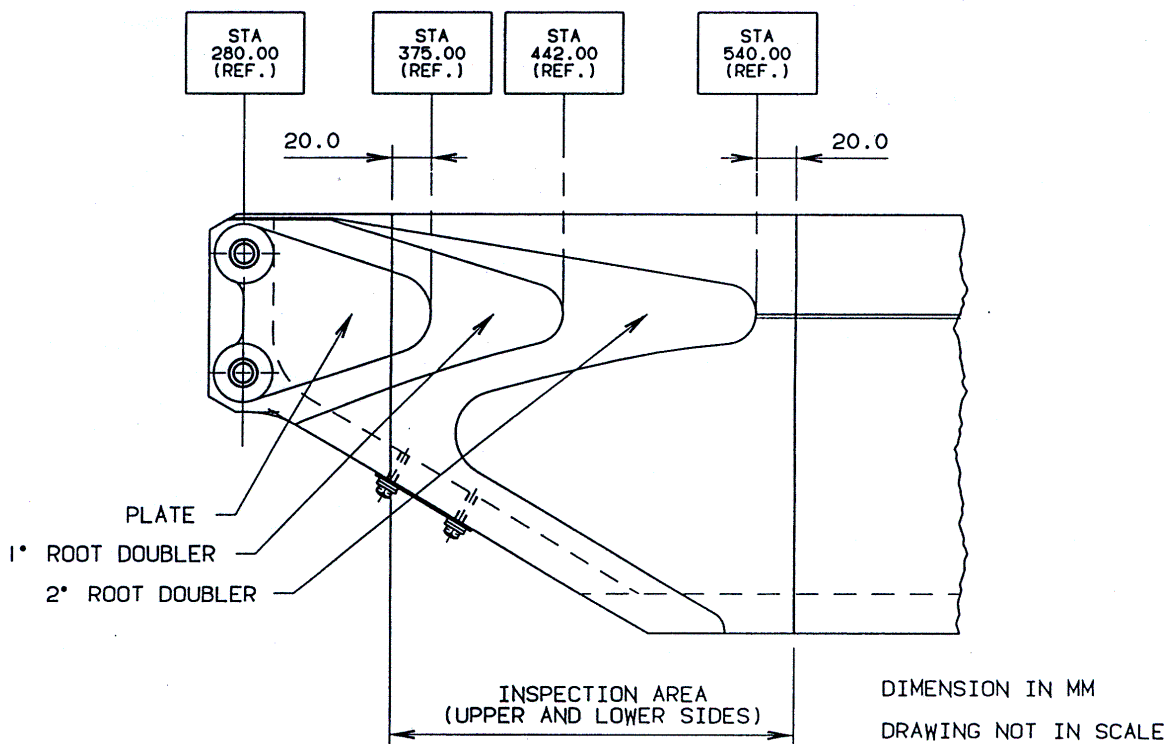
FIGURE 1

(a) Before each start of the engines, visually check both sides of each blade for a crack, in the area shown in Figure 1. An owner/operator (pilot), holding at least a private pilot certificate, may perform the visual check required by this paragraph and must enter compliance into the aircraft maintenance records in accordance with 14 CFR 43.11 and 91.417(a)(2)(v).

Note: Paint irregularities may be due to cracks.

(d) If a crack is found, replace the blade with an airworthy blade before further flight.
